**Flood Control Project Maintenance
Levee Inspections**

Maintenance Issue Types Only, Levee Inspection Report By Mile - Spring 2018

Reclamation District No. 2062 Stewart

Waterway	Bank	Unit Miles	Inspection Start/End	Inspector
Unit No. 01 San Joaquin River	Left	2.64	05/22/2018 05/22/2018	Richard Willoughby

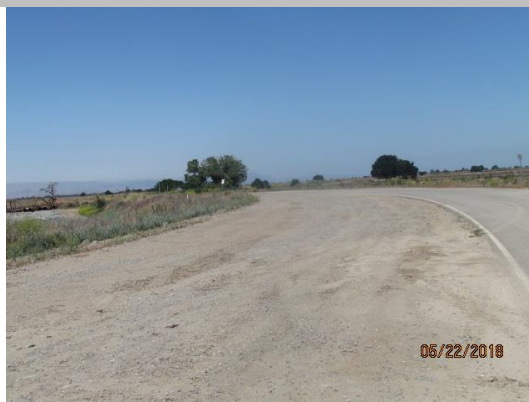
Photo 1 of 1 : SP_2018_RD2062_309_6_20180523_00011.jpg

LM Start	0.00	Rating **	M	Issue No.	6
LM End	2.64	Issue Type +	Ma	Location *	LS
Category	Earthen Levee			GPS Latitude/Longitude	
				Start	End
Item	Vegetation			37.807505 °	37.787249 °
				-121.328103 °	-121.308947 °
DWR ID	DWR_RD2062_01_s_2018_6				
Comment Code					
V1 : Control annual grass and weeds on the levee slopes and easements.					
Inspector Comment

Looking downstream at typical view of landward slope.

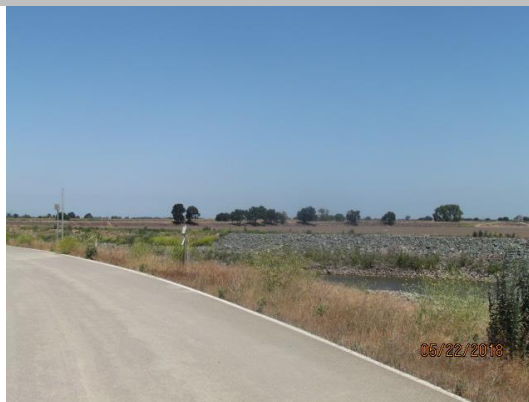
Photo 1 of 1 : SP_2018_RD2062_309_7_20180523_00010.jpg

LM Start	0.00	Rating **	M	Issue No.	7
LM End	2.64	Issue Type +	Ma	Location *	WS
Category	Earthen Levee			GPS Latitude/Longitude	
				Start	End
Item	Vegetation			37.807505 °	37.787247 °
				-121.328103 °	-121.308948 °
DWR ID	DWR_RD2062_01_s_2018_7				
Comment Code					
V1 : Control annual grass and weeds on the levee slopes and easements.					
Inspector Comment

Looking upstream at typical view of waterward slope.

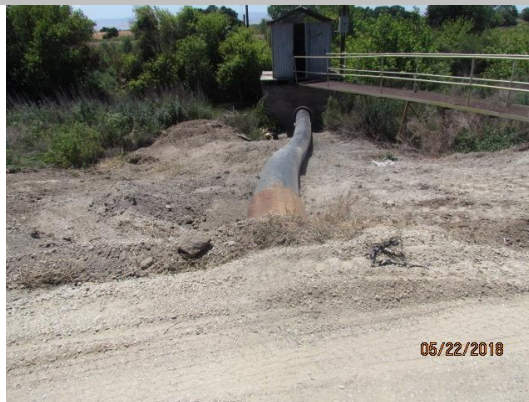
Photo 1 of 4 : SP_2018_RD2062_310_14_20180523_00031.jpg

Looking east at pump house and pipe on waterward slope. (Spring 2018)

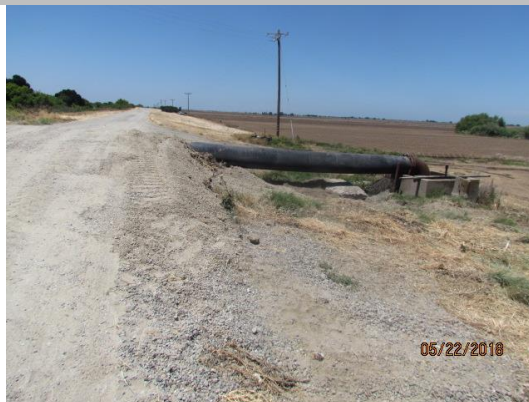
Photo 2 of 4 : SP_2018_RD2062_310_14_20180523_00032.jpg

LM Start	1.37	Rating **	U	Issue No.	14 (cont)
LM End	1.37	Issue Type +	Ma	Location *	CR

Looking south at installation (pipe) on landward slope. (Spring 2018)

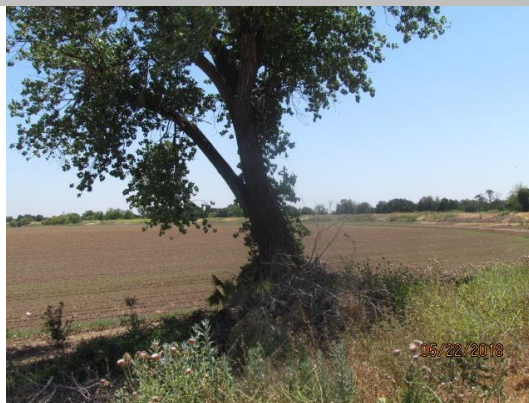
Photo 1 of 1 : SP_2018_RD2062_310_12_20180523_00034.jpg

Looking at broken tree branch on landward slope. (Spring 2018)

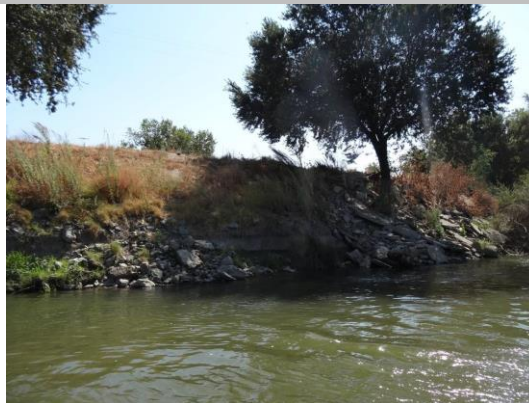
Photo 1 of 4 : SP_2018_RD2062_311_1_20180503_00001.jpg

LM Start	-0.03	Rating **	M	Issue No.	1
LM End	0.07	Issue Type +	Ma	Location *	WS
Category	Supplemental			GPS Latitude/Longitude	
				Start	End
Item	DWR Erosion Survey			37.809514 °	37.809514 °
				-121.390125 °	-121.390125 °
DWR ID	RD2062U03RM29.94				
Comment Code					
Inspector Comment					
09/13/2017: The erosion site has expanded significantly along the river bank.					
11/09/2016: No significant change observed.					
06/25/2015: The erosion is below a large oak tree. Vegetation is visible around the erosion site. [2017 Site ID:RD2062U03RM29.94]

Front view of the erosion site. Note the large tree above the erosion.

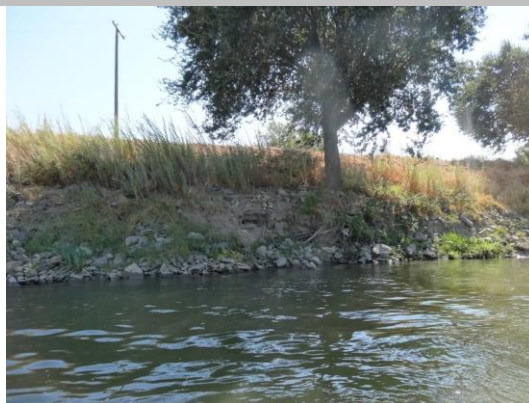
Photo 2 of 4 : SP_2018_RD2062_311_1_20180503_00002.jpg

Close view of the erosion.

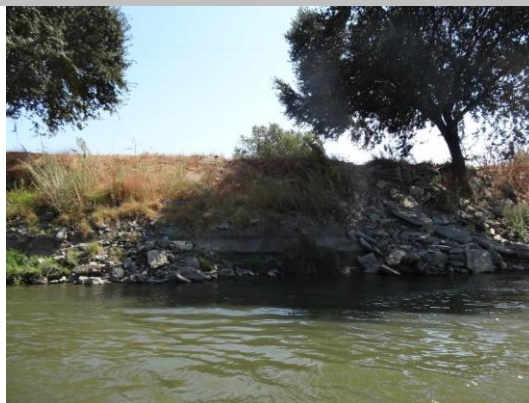
Photo 3 of 4 : SP_2018_RD2062_311_1_20180503_00003.jpg

LM Start	-0.03	Rating **	M	Issue No.	1 (cont)
LM End	0.07	Issue Type +	Ma	Location *	WS

Close view of the erosion.

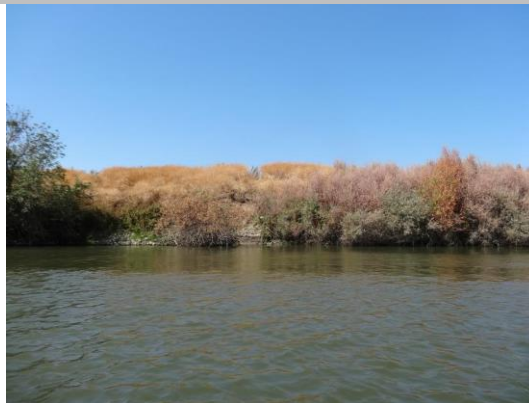
Photo 4 of 4 : SP_2018_RD2062_311_1_20180503_00004.jpg

LM Start	-0.03	Rating **	M	Issue No.	1 (cont)	
LM End	0.07	Issue Type +	Ma	Location *	WS	
Category	Supplemental			GPS Latitude/Longitude		
				Start		End
Item	DWR Erosion Survey			37.809514 °		37.809514 °
				-121.390125 °		-121.390125 °
DWR ID	RD2062U03RM29.94					
Comment Code						
Inspector Comment						
09/13/2017: The erosion site has expanded significantly along the river bank.						
11/09/2016: No significant change observed.						
06/25/2015: The erosion is below a large oak tree. Vegetation is visible around the erosion site. [2017 Site ID:RD2062U03RM29.94]

Close view of the erosion.

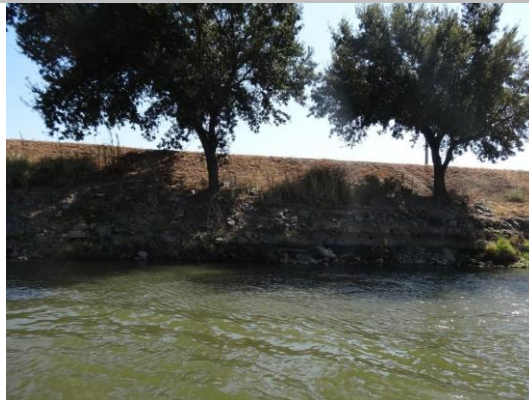
Photo 1 of 4 : SP_2018_RD2062_311_2_20180503_00005.jpg

Comment Code					
Inspector Comment					
09/13/2017: The erosion site has expanded significantly with the erosion length increased to approximately 90 ft from 40 ft. Signs of animal activities have been found at the site.					
07/25/2016: No significant change observed.					
06/25/2015: No significant change observed.					
07/02/2014: No significant change observed.					
08/13/2013: No significant change observed.					
08/07/2012: The site has been visited by boat survey. No significant change observed					
08/23/2011: Hard to view the erosion because of the dense vegetation and trees on site. The site is under the bush, close to the tree. [2017 Site ID:RD2062U03RM30.02]

Front view of the site.

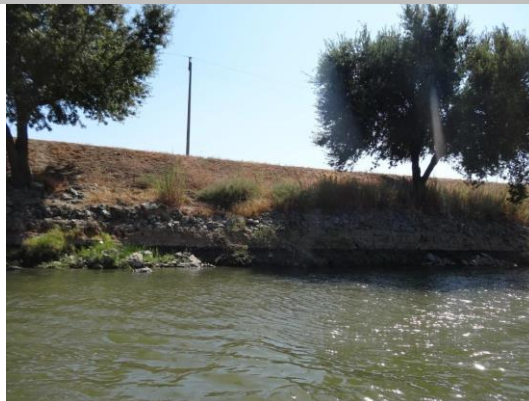
Photo 2 of 4 : SP_2018_RD2062_311_2_20180503_00006.jpg

Comment Code						
Inspector Comment						
09/13/2017: The erosion site has expanded significantly with the erosion length increased to approximately 90 ft from 40 ft. Signs of animal activities have been found at the site.						
07/25/2016: No significant change observed.						
06/25/2015: No significant change observed.						
07/02/2014: No significant change observed.						
08/13/2013: No significant change observed.						
08/07/2012: The site has been visited by boat survey. No significant change observed						
08/23/2011: Hard to view the erosion because of the dense vegetation and trees on site. The site is under the bush, close to the tree. [2017 Site ID:RD2062U03RM30.02]

Close view of the erosion. Note signs of animal activities at the site..

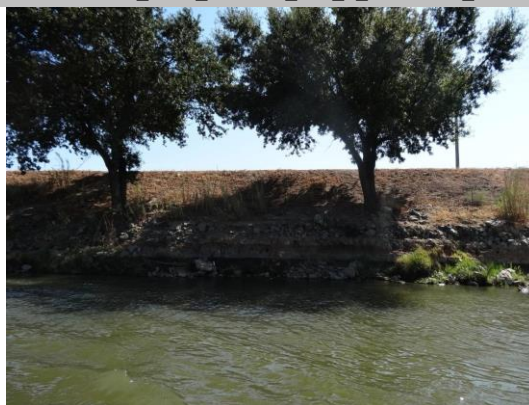
Photo 3 of 4 : SP_2018_RD2062_311_2_20180503_00007.jpg

Close view of the erosion.

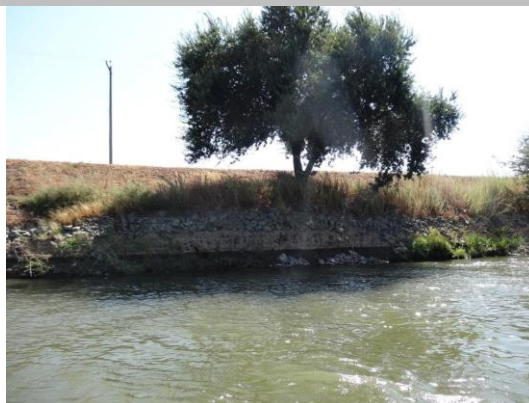
Photo 4 of 4 : SP_2018_RD2062_311_2_20180503_00008.jpg

Comment Code						
Inspector Comment						
09/13/2017: The erosion site has expanded significantly with the erosion length increased to approximately 90 ft from 40 ft. Signs of animal activities have been found at the site.						
07/25/2016: No significant change observed.						
06/25/2015: No significant change observed.						
07/02/2014: No significant change observed.						
08/13/2013: No significant change observed.						
08/07/2012: The site has been visited by boat survey. No significant change observed						
08/23/2011: Hard to view the erosion because of the dense vegetation and trees on site. The site is under the bush, close to the tree. [2017 Site ID:RD2062U03RM30.02]

Close view of the erosion.

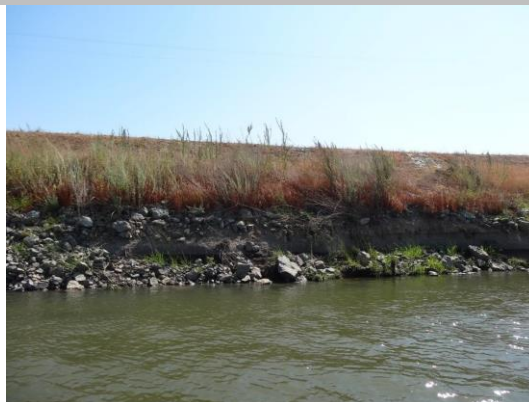
Photo 1 of 3 : SP_2018_RD2062_311_3_20180503_00009.jpg

LM Start	0.17	Rating **	M	Issue No.	3
LM End	0.17	Issue Type +	Ma	Location *	WS
Category	Supplemental			GPS Latitude/Longitude	
				Start	End
Item	DWR Erosion Survey			37.810268 °	37.810268 °
				-121.387495 °	-121.387495 °
DWR ID	DWR_RD2062_03_s_2018_3				
Comment Code					
Inspector Comment					
09/13/2017: No significant change observed.					
07/25/2016: No significant change observed.					
06/25/2015: No significant change observed.					
07/02/2014: No significant change observed.					
08/13/2013: No significant change observed.					
08/07/2012: The site has been visited by boat survey. No significant change observed					
08/23/2011: The protection at the levee toe has been washed away.					
[2017 Site ID:RD2062U03RM30.1]

Direct view of the site.

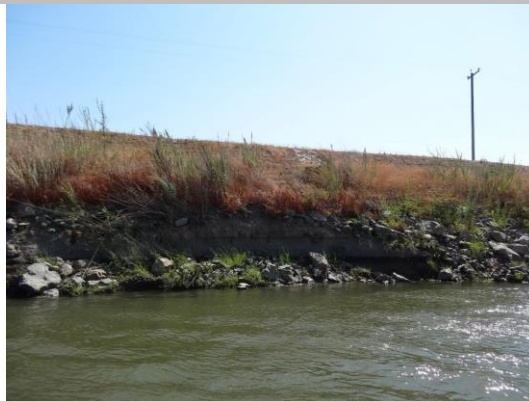
Photo 2 of 3 : SP_2018_RD2062_311_3_20180503_00010.jpg

LM Start	0.17	Rating **	M	Issue No.	3 (cont)	
LM End	0.17	Issue Type +	Ma	Location *	WS	
Category	Supplemental			GPS Latitude/Longitude		
				Start		End
Item	DWR Erosion Survey			37.810268 °		37.810268 °
				-121.387495 °		-121.387495 °
DWR ID	DWR_RD2062_03_s_2018_3					
Comment Code						
Inspector Comment						
09/13/2017: No significant change observed.						
07/25/2016: No significant change observed.						
06/25/2015: No significant change observed.						
07/02/2014: No significant change observed.						
08/13/2013: No significant change observed.						
08/07/2012: The site has been visited by boat survey. No significant change observed						
08/23/2011: The protection at the levee toe has been washed away.						
[2017 Site ID:RD2062U03RM30.1]

Close view of the erosion.

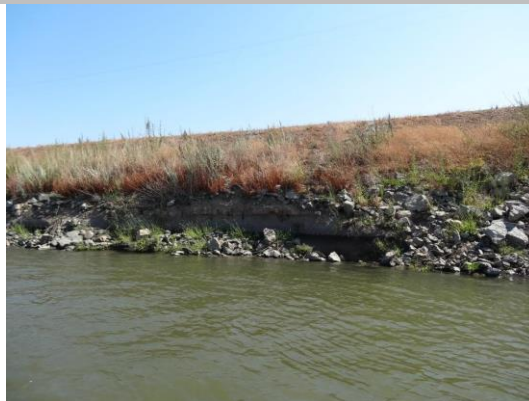
Photo 3 of 3 : SP_2018_RD2062_311_3_20180503_00011.jpg

LM Start	0.17	Rating **	M	Issue No.	3 (cont)
LM End	0.17	Issue Type +	Ma	Location *	WS

Close view of the erosion.

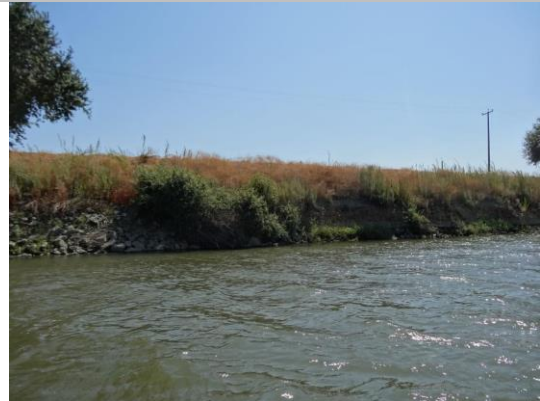
Photo 1 of 4 : SP_2018_RD2062_311_4_20180503_00012.jpg

Comment Code					
Inspector Comment					
09/13/2017: The erosion has developed vertically. More vegetaion at the site.					
07/25/2106: No significant change observed. More vegetation observed at the site.					
06/25/2015: No significant change observed.					
07/02/2014: No significant change observed.					
08/13/2013: A new pocket erosion at the upper levee slope has been found directly above a large tree. The erosion might have been caused by internal pipe leakage or surface runoff.					
08/07/2012: The site has been visited by boat survey. No significant change observed					
08/23/2011: No significant change observed on site. Dense vegetation is visible along the water line.					
09/07/2010: No significant change observed on site. Much of the upper slope was recently cleared of vegetation by spraying. 4- to 6-foot vertical scarp and pocket erosions are lined along a span of 475 feet. In some sections, the vertical scarp encroaches into the levee prism. There is a lack of berm along this reach, exposing the levee slope to high flow velocities during normal and flood events.

08/06/2010: Recommended as local maintenance issue, per CLRO.					
03/09/2010: As discussed with Michael Moncrief of MBK Engineers, the site will be 'addressed' later this year.					
09/29/2009: No major change observed since last visit; pocket erosion and a vertical scarp forming; this site was combined with Site RM30.13 and 30.02 with a combined total erosion length of 475 feet; recommended as annual assessment and monitoring of the site, per CLRO CES Evaluation 2008 Report; previously rated "M".					
11/05/2008: Top of vertical scarp has rip rap that appears to be sliding; rodent holes; existing toe rip rap. [2017 Site ID:RD2062U03RM30.19]

View of the pocket erosion.

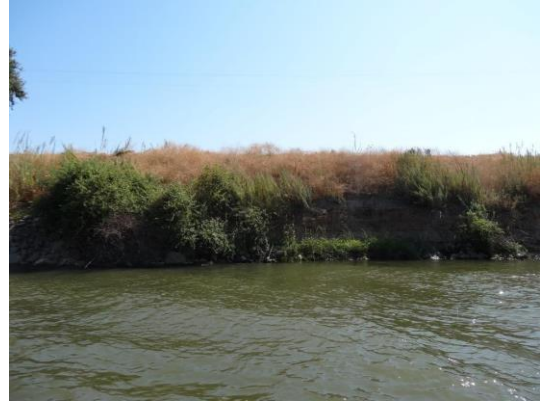
Photo 2 of 4 : SP_2018_RD2062_311_4_20180503_00013.jpg

Comment Code					
Inspector Comment					
09/13/2017: The erosion has developed vertically. More vegetaion at the site.					
07/25/2106: No significant change observed. More vegetation observed at the site.					
06/25/2015: No significant change observed.					
07/02/2014: No significant change observed.					
08/13/2013: A new pocket erosion at the upper levee slope has been found directly above a large tree. The erosion might have been caused by internal pipe leakage or surface runoff.					
08/07/2012: The site has been visited by boat survey. No significant change observed					
08/23/2011: No significant change observed on site. Dense vegetation is visible along the water line.					
09/07/2010: No significant change observed on site. Much of the upper slope was recently cleared of vegetation by spraying. 4- to 6-foot vertical scarp and pocket erosions are lined along a span of 475 feet. In some sections, the vertical scarp encroaches into the levee prism. There is a lack of berm along this reach, exposing the levee slope to high flow velocities during normal and flood events.

08/06/2010: Recommended as local maintenance issue, per CLRO.					
03/09/2010: As discussed with Michael Moncrief of MBK Engineers, the site will be 'addressed' later this year.					
09/29/2009: No major change observed since last visit; pocket erosion and a vertical scarp forming; this site was combined with Site RM30.13 and 30.02 with a combined total erosion length of 475 feet; recommended as annual assessment and monitoring of the site, per CLRO CES Evaluation 2008 Report; previously rated "M".					
11/05/2008: Top of vertical scarp has rip rap that appears to be sliding; rodent holes; existing toe rip rap. [2017 Site ID:RD2062U03RM30.19]

Close view of the pocket erosion. Note the dense vegetation at the site.

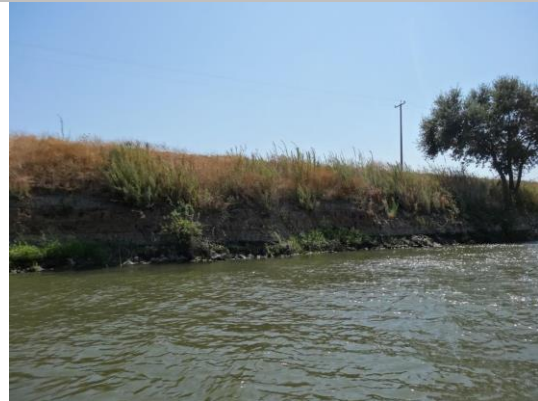
Photo 3 of 4 : SP_2018_RD2062_311_4_20180503_00014.jpg

Comment Code						
Inspector Comment						
09/13/2017: The erosion has developed vertically. More vegetaion at the site.						
07/25/2106: No significant change observed. More vegetation observed at the site.						
06/25/2015: No significant change observed.						
07/02/2014: No significant change observed.						
08/13/2013: A new pocket erosion at the upper levee slope has been found directly above a large tree. The erosion might have been caused by internal pipe leakage or surface runoff.						
08/07/2012: The site has been visited by boat survey. No significant change observed						
08/23/2011: No significant change observed on site. Dense vegetation is visible along the water line.						
09/07/2010: No significant change observed on site. Much of the upper slope was recently cleared of vegetation by spraying. 4- to 6-foot vertical scarp and pocket erosions are lined along a span of 475 feet. In some sections, the vertical scarp encroaches into the levee prism. There is a lack of berm along this reach, exposing the levee slope to high flow velocities during normal and flood events.

08/06/2010: Recommended as local maintenance issue, per CLRO.						
03/09/2010: As discussed with Michael Moncrief of MBK Engineers, the site will be 'addressed' later this year.						
09/29/2009: No major change observed since last visit; pocket erosion and a vertical scarp forming; this site was combined with Site RM30.13 and 30.02 with a combined total erosion length of 475 feet; recommended as annual assessment and monitoring of the site, per CLRO CES Evaluation 2008 Report; previously rated "M".						
11/05/2008: Top of vertical scarp has rip rap that appears to be sliding; rodent holes; existing toe rip rap. [2017 Site ID:RD2062U03RM30.19]

Front view of the site with dense vegetation.

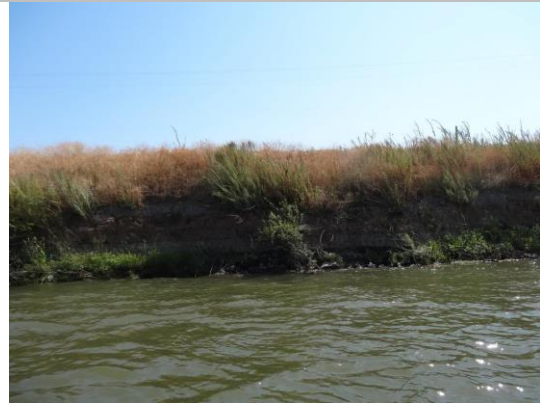
Photo 4 of 4 : SP_2018_RD2062_311_4_20180503_00015.jpg

Comment Code						
Inspector Comment						
09/13/2017: The erosion has developed vertically. More vegetaion at the site.						
07/25/2106: No significant change observed. More vegetation observed at the site.						
06/25/2015: No significant change observed.						
07/02/2014: No significant change observed.						
08/13/2013: A new pocket erosion at the upper levee slope has been found directly above a large tree. The erosion might have been caused by internal pipe leakage or surface runoff.						
08/07/2012: The site has been visited by boat survey. No significant change observed						
08/23/2011: No significant change observed on site. Dense vegetation is visible along the water line.						
09/07/2010: No significant change observed on site. Much of the upper slope was recently cleared of vegetation by spraying. 4- to 6-foot vertical scarp and pocket erosions are lined along a span of 475 feet. In some sections, the vertical scarp encroaches into the levee prism. There is a lack of berm along this reach, exposing the levee slope to high flow velocities during normal and flood events.

08/06/2010: Recommended as local maintenance issue, per CLRO.						
03/09/2010: As discussed with Michael Moncrief of MBK Engineers, the site will be 'addressed' later this year.						
09/29/2009: No major change observed since last visit; pocket erosion and a vertical scarp forming; this site was combined with Site RM30.13 and 30.02 with a combined total erosion length of 475 feet; recommended as annual assessment and monitoring of the site, per CLRO CES Evaluation 2008 Report; previously rated "M".						
11/05/2008: Top of vertical scarp has rip rap that appears to be sliding; rodent holes; existing toe rip rap. [2017 Site ID:RD2062U03RM30.19]

Front view of the site. The erosion has developed along the levee slope.

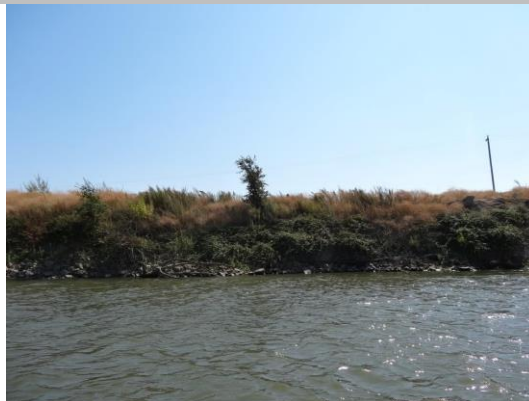
Photo 1 of 3 : SP_2018_RD2062_311_5_20180503_00016.jpg

LM Start	0.35	Rating **	M	Issue No.	5
LM End	0.35	Issue Type +	Ma	Location *	WS
Category	Supplemental			GPS Latitude/Longitude	
				Start	End
Item	DWR Erosion Survey			37.811101 °	37.811101 °
				-121.384402 °	-121.384402 °
DWR ID	RD2062U03RM30.27				
Comment Code					
Inspector Comment					
09/13/2017: No significant change observed.					
07/25/2016: No significant change observed.					
06/25/2015: No significant change observed.					
07/02/2014: No significant change observed.					
08/13/2013: No significant change observed.					
08/07/2012: The site has been visited by boat survey. No significant change observed					
08/23/2011: The site is right at the downstream of a river bend. [2017 Site ID:RD2062U03RM30.27]

Front view of the erosion.

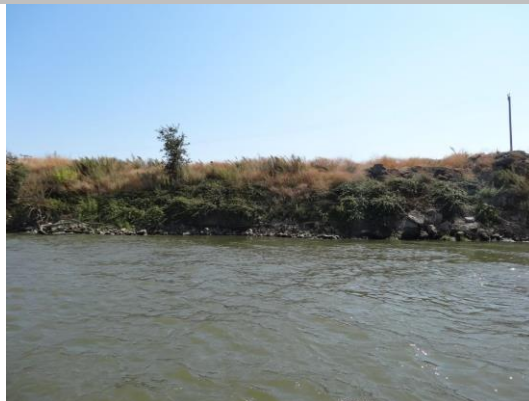
Photo 2 of 3 : SP_2018_RD2062_311_5_20180503_00017.jpg

LM Start	0.35	Rating **	M	Issue No.	5 (cont)
LM End	0.35	Issue Type +	Ma	Location *	WS

Close view of the site. Note the dense vegetation at the site.

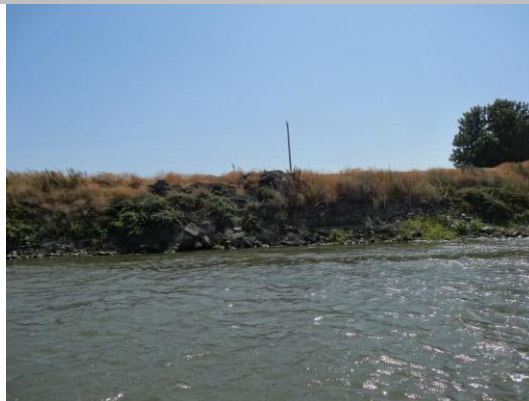
Photo 3 of 3 : SP_2018_RD2062_311_5_20180503_00018.jpg

LM Start	0.35	Rating **	M	Issue No.	5 (cont)	
LM End	0.35	Issue Type +	Ma	Location *	WS	
Category	Supplemental			GPS Latitude/Longitude		
				Start		End
Item	DWR Erosion Survey			37.811101 °		37.811101 °
				-121.384402 °		-121.384402 °
DWR ID	RD2062U03RM30.27					
Comment Code						
Inspector Comment						
09/13/2017: No significant change observed.						
07/25/2016: No significant change observed.						
06/25/2015: No significant change observed.						
07/02/2014: No significant change observed.						
08/13/2013: No significant change observed.						
08/07/2012: The site has been visited by boat survey. No significant change observed						
08/23/2011: The site is right at the downstream of a river bend. [2017 Site ID:RD2062U03RM30.27]

Front view of the erosion.

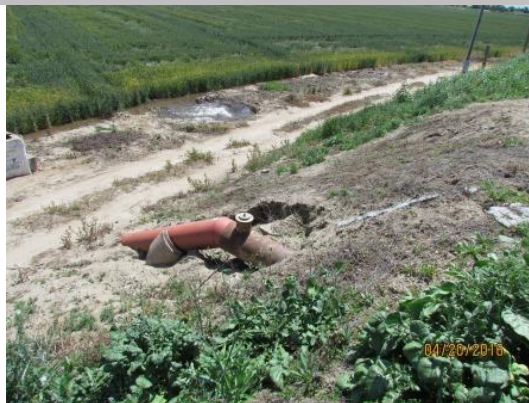
Photo 1 of 1 : SP_2018_RD2062_311_38_20180503_00036.jpg

LM Start	0.51	Rating **	M	Issue No.	38
LM End	0.51	Issue Type +	Ma	Location *	LS
Category	Earthen Levee			GPS Latitude/Longitude	
				Start	End
Item	Erosion / Bank Caving			37.812552 °	37.812552 °
				-121.382781 °	-121.382781 °
DWR ID	DWR_RD2062_03_s_2016_38				
Comment Code					
E2 : Schedule repair of erosion site prior to the next inspection.					
Inspector Comment

View of the landside levee slope erosion around the pipe.

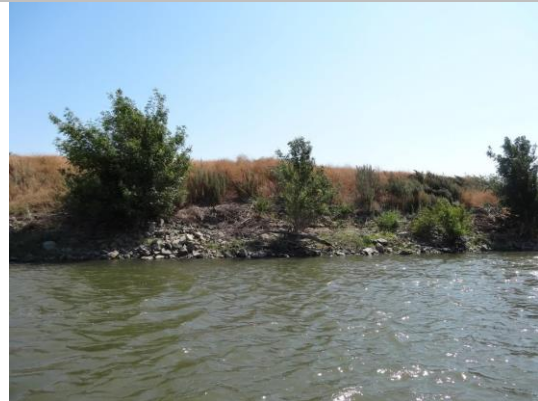
Photo 1 of 3 : SP_2018_RD2062_311_7_20180503_00019.jpg

09/13/2017: No significant change observed.
 07/25/2016: No significant change observed.
 06/25/2015: No significant change observed.
 07/02/2014: No significant change observed.
 08/13/2013: No significant change observed.
 08/07/2012: The site has been visited by boat survey. No significant change observed.
 08/23/2011: No significant change observed on site.
 09/07/2010: No significant change observed on site. Much of the placed rip rap revetment has slid. It is no longer adequately protecting the slope.
 08/06/2010: Recommended as local maintenance issue, per CLRO Report.
 03/09/2010: As discussed with Michael Moncrief of MBK, site will be 'addressed' this year.
 09/29/2009: No major change observed since last visit; a section of the rip rap has slipped, exposing a levee section that has eroded; recommended as local maintenance issue, per CLRO CES Evaluation 2008 Report; Site # is the same as RM30.43, LM0.63; previously rated "U".

Close view of the site.

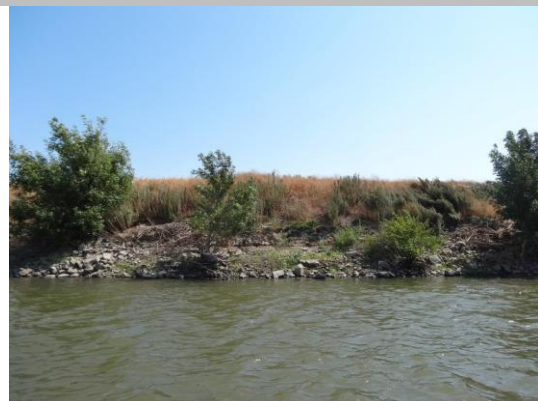
Photo 2 of 3 : SP_2018_RD2062_311_7_20180503_00020.jpg

Front view of the site.

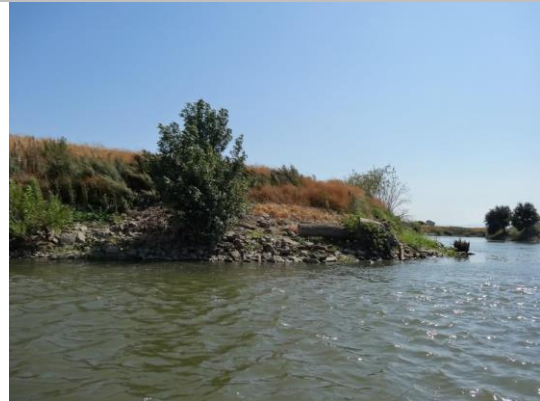
Photo 3 of 3 : SP_2018_RD2062_311_7_20180503_00021.jpg

Comment Code						
Inspector Comment						
09/13/2017: No significant change observed.						
07/25/2016: No significant change observed.						
06/25/2015: No significant change observed.						
07/02/2014: No significant change observed.						
08/13/2013: No significant change observed.						
08/07/2012: The site has been visited by boat survey. No significant change observed.						
08/23/2011: No significant change observed on site.						
09/07/2010: No significant change observed on site. Much of the placed rip rap revetment has slid. It is no longer adequately protecting the slope.						
08/06/2010: Recommended as local maintenance issue, per CLRO Report.						
03/09/2010: As discussed with Michael Moncrief of MBK, site will be 'addressed' this year.						
09/29/2009: No major change observed since last visit; a section of the rip rap has slipped, exposing a levee section that has eroded; recommended as local maintenance issue, per CLRO CES Evaluation 2008 Report; Site # is the same as RM30.43,LM0.63; previously rated "U".

Front view of the site.

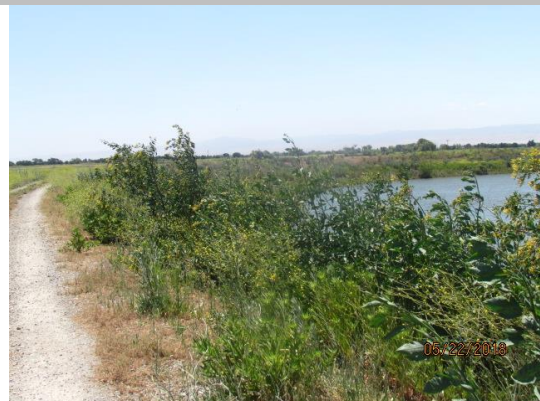
Photo 1 of 1 : SP_2018_RD2062_311_22_20180523_00052.jpg

LM Start	0.74	Rating **	U	Issue No.	22
LM End	0.76	Issue Type +	Ma	Location *	WS
Category	Earthen Levee			GPS Latitude/Longitude	
				Start	End
Item	Vegetation			37.815262 °	37.815557 °
				-121.381455 °	-121.381562 °
DWR ID	DWR_RD2062_03_s_2018_22				
Comment Code					
V2 : Remove the wild growth other than native grasses from the levee slopes.					
Inspector Comment

Looking southwest at dense vegetation (Tobacco plants) on waterward slope. (Spring 2018)

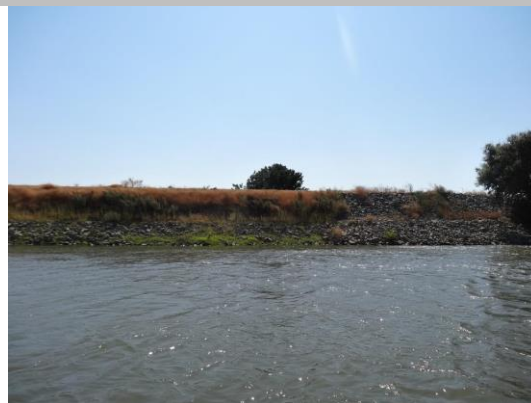
Photo 1 of 3 : SP_2018_RD2062_311_8_20180503_00022.jpg

09/13/2017: No significant change observed.
 07/25/2016: No significant change observed.
 06/25/2015: No significant change observed.
 07/02/2014: No significant change observed.
 08/13/2013: No significant change observed.
 08/07/2012: The site has been visited by boat survey. No significant change observed
 08/23/2011: No significant change observed on site.
 09/07/2010: No significant change observed on site. Much of the seasonal grass along the slope was cleared. Site consists of an existing scalloped erosion approximately 30 feet long by 5 feet wide at its widest opening. The lateral crack is extended outwards along the middle slope. There is a 1 to 2 feet of differential settlement that could further develop into a shallow slide.
 08/06/2010: Recommended as local maintenance issue, per CLRO.
 03/09/2010: As discussed with Michael Moncrief of MBK Engineer, site will be 'addressed' this year.
 09/28/2009: No major change observed; section of rip rap has slipped, creating a terraced effect; dense vegetation growth; recommended as a local maintenance issue, per CLRO CES Evaluation 2008 Report; Site # is the same as RM31.12,LM1.25; previously rated "U".

Front view of the site.

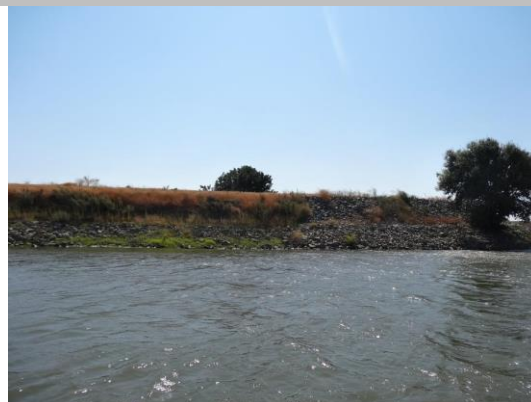
Photo 2 of 3 : SP_2018_RD2062_311_8_20180503_00023.jpg

Front view of the site.

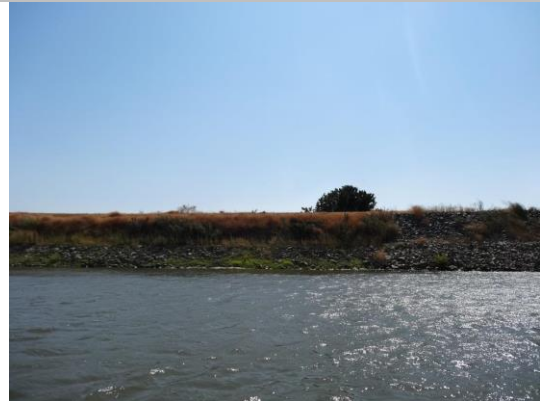
Photo 3 of 3 : SP_2018_RD2062_311_8_20180503_00024.jpg

Comment Code						
Inspector Comment						
09/13/2017: No significant change observed.						
07/25/2016: No significant change observed.						
06/25/2015: No significant change observed.						
07/02/2014: No significant change observed.						
08/13/2013: No significant change observed.						
08/07/2012: The site has been visited by boat survey. No significant change observed						
08/23/2011: No significant change observed on site.						
09/07/2010: No significant change observed on site. Much of the seasonal grass along the slope was cleared. Site consists of an existing scalloped erosion approximately 30 feet long by 5 feet wide at its widest opening. The lateral crack is extended outwards along the middle slope. There is a 1 to 2 feet of differential settlement that could further develop into a shallow slide.						
08/06/2010: Recommended as local maintenance issue, per CLRO.						
03/09/2010: As discussed with Michael Moncrief of MBK Engineer, site will be 'addressed' this year.

09/28/2009: No major change observed; section of rip rap has slipped, creating a terraced effect; dense vegetation growth; recommended as a local maintenance issue, per CLRO CES Evaluation 2008 Report; Site # is the same as RM31.12,LM1.25; previously rated "U".						
09/14/2006: 1-2' into prism. [2017 Site ID:RD2062U03RM31.12]

Front view of the site.

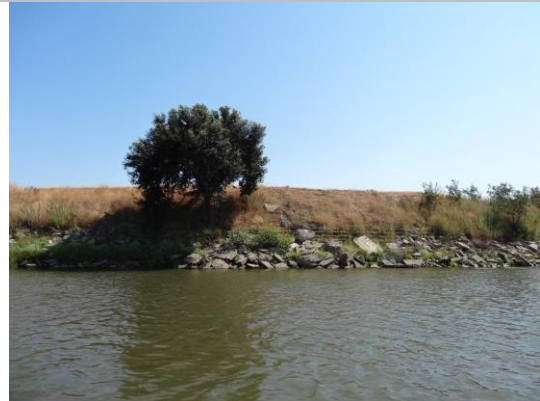
Photo 1 of 4 : SP_2018_RD2062_311_9_20180503_00025.jpg

09/13/2017: No significant change observed.
 07/25/2016: No significant change observed.
 06/25/2015: No significant change observed.
 07/02/2014: No significant change observed.
 08/13/2013: No significant change observed.
 08/07/2012: The site has been visited by boat survey. No significant change observed.
 08/23/2011: No significant change observed on site.
 09/07/2010: No significant change observed on site. There is a small- to medium sized Oak tree on the mid-slope just above rip rap. Some of the rip rap has collapsed, creating a pocket erosion just above the existing toe rip rap and upstream of the Oak tree.
 08/06/2010: Recommended as local maintenance issue, per CLRO.
 03/09/2010: As discussed with Michael Moncrief of MBK Engineer, site will be 'addressed' in 2010.
 09/29/2009: No major change since last visit; sliding of the rip rap at the base of the lone tree; there is noticeable man-made trail and foot traffic extending from the crown to the toe; much of the broken concrete used as temporary rip rap has slid, exposing portion of the bare levee slope; recommended as local maintenance issue, per CLRO CES Evaluation 2008 Report; Site # is the same as RM31.3, LM1.45; previously rated "M".

Front view of the erosion site.

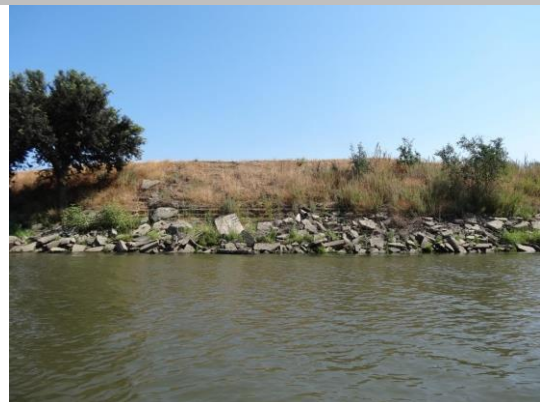
Photo 2 of 4 : SP_2018_RD2062_311_9_20180503_00026.jpg

Close view of the site.

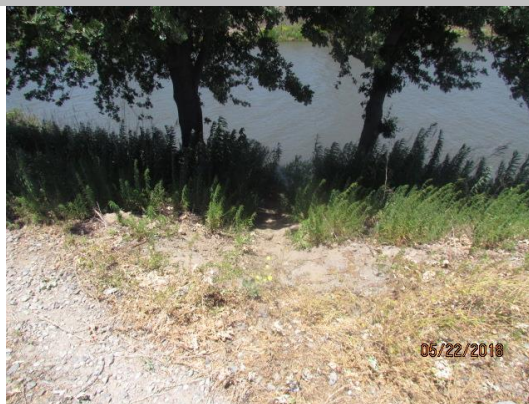
Photo 1 of 1 : SP_2018_RD2062_311_20_20180523_00053.jpg

LM Start	2.18	Rating **	M	Issue No.	20
LM End	2.18	Issue Type +	Ma	Location *	WS
Category	Earthen Levee			GPS Latitude/Longitude	
				Start	End
Item	Slope Stability			37.818725 °	37.818725 °
				-121.363762 °	-121.363762 °
DWR ID	DWR_RD2062_03_s_2018_20				
Comment Code					
S2 : Repair the levee slope damaged by foot traffic and prevent access where possible.					
Inspector Comment					
Slope damage caused by foot traffic on waterward slope.

Looking west at slope damage (foot traffic) on waterward slope. (Spring 2018)

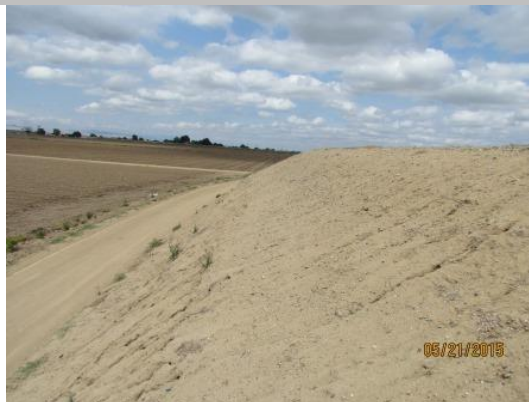
Photo 1 of 1 : SP_2018_RD2062_311_31_20180503_00033.jpg

LM Start	3.61	Rating **	M	Issue No.	31
LM End	3.66	Issue Type +	Ma	Location *	LS
Category	Earthen Levee			GPS Latitude/Longitude	
				Start	End
Item	Erosion / Bank Caving			37.816982 °	37.816541 °
				-121.342939 °	-121.342191 °
DWR ID	DWR_RD2062_03_s_2015_31				
Comment Code					
E2 : Schedule repair of erosion site prior to the next inspection.					
Inspector Comment					
About a 3 ft vertical cut at the levee toe into the levee prism.

View of the eroded landside levee toe.

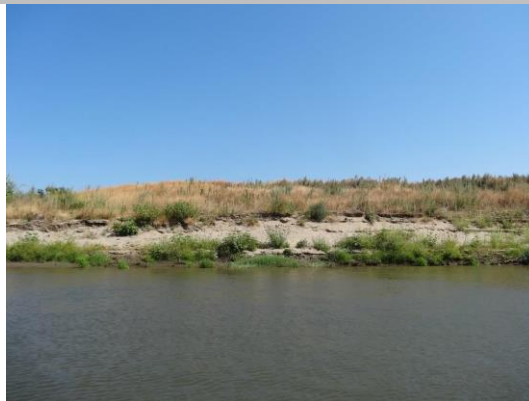
Photo 3 of 3 : SP_2018_RD2062_311_10_20180503_00031.jpg

Close view of the erosion. Note the sandy material of the river bank at the erosion site.

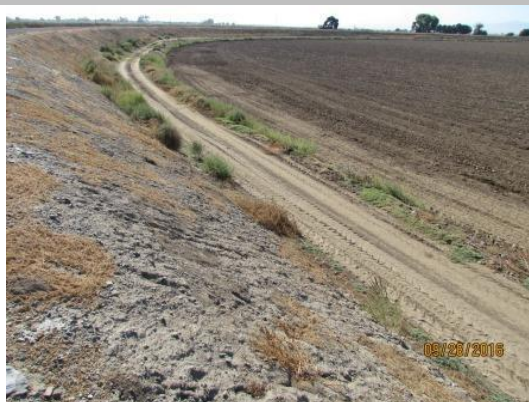
Photo 1 of 1 : SP_2018_RD2062_311_37_20180503_00035.jpg

LM Start	4.30	Rating **	M	Issue No.	37
LM End	4.35	Issue Type +	Ma	Location *	LS
Category	Earthen Levee			GPS Latitude/Longitude	
				Start	End
Item	Erosion / Bank Caving			37.819436 °	37.819096 °
				-121.335469 °	-121.334829 °
DWR ID	DWR_RD2062_03_f_2016_37				
Comment Code					
E2 : Schedule repair of erosion site prior to the next inspection.					
Inspector Comment					
Toe road encroaches into the levee toe.

View of the toe road encroaching into the levee prism.

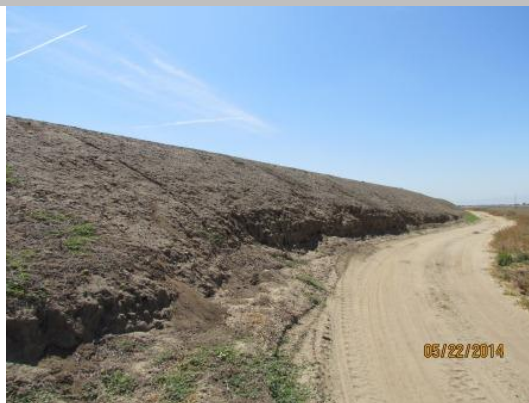
Photo 1 of 1 : SP_2018_RD2062_311_35_20180503_00034.jpg

View of a 2-3 feet vertical cut at the landside levee toe.

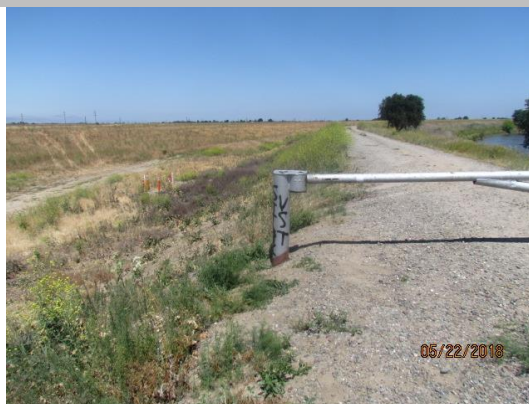
Photo 1 of 1 : SP_2018_RD2062_311_17_20180523_00054.jpg

LM Start	5.16	Rating **	U	Issue No.	17
LM End	5.16	Issue Type +	Ma	Location *	CR
Category	Earthen Levee			GPS Latitude/Longitude	
				Start	End
Item	Repair Gates			37.808432 °	37.808432 °
				-121.334767 °	-121.334767 °
DWR ID	DWR_RD2062_03_s_2018_17				
Comment Code					
Inspector Comment					
Lock system (mechanism) should be replace safety issue. Was not able to remove lock to hard to reach due to position of lock.

Looking north at gate (lock mechanism) should be replace or fixed.
(Spring 2018)

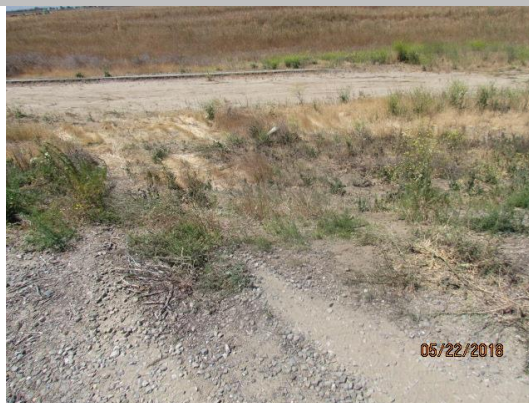
Photo 1 of 1 : SP_2018_RD2062_311_19_20180523_00055.jpg

Looking west slope damage due to vehicle traffic. (Spring 2018)
